# Analysis of damage modes of glass fiber composites subjected to simulated lightning strike impulse voltage puncture and direct high voltage AC puncture

Journal of Composite Materials  
2020, Vol. 54(26) 4067–4080  
© The Author(s) 2020  
Article reuse guidelines:  
sagepub.com/journals-permissions  
DOI: 10.1177/0021998320927736  
journals.sagepub.com/home/jcm

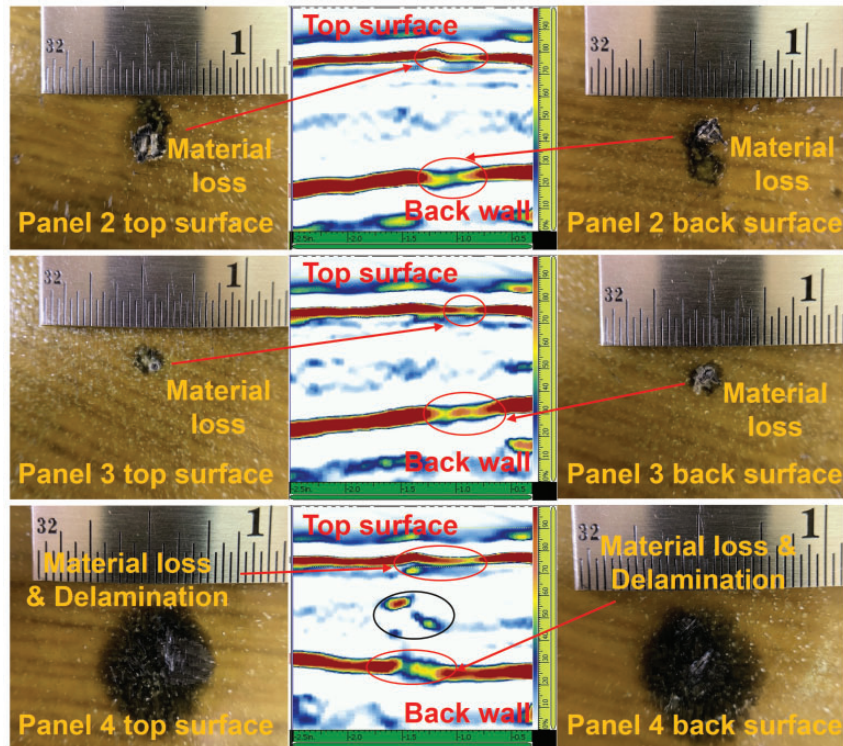
**Figure 4.** (a) Top side high voltage puncture damage of Panels 2, 3, and 4; (b) S-scan images; and (c) bottom side damage.

Visual inspections for both sides of the panels are shown in Figure 4. It can be observed that for all panels subjected to high voltage tests, the damages

were all inflicted near the outermost circumferential regions (within 2.5 mm) of the bonded washer or electrodes rather than at the center or anywhere in between. The electrical field is enhanced at the edge of the electrode (or washer)<sup>43</sup> and hence initiated the damage near the outermost circumferential regions then propagates through the thickness direction with the least resistive path to meet the grounding on the other side of the GFRP composite panel. Here, the least resistive path refers to the path linking to the GFRP composite deficiencies inside the GFRP, which are inevitably introduced during the manufacture process (e.g. voids, resin and fiber non-uniformity). For Panels 2 and 3, which were subjected to HVAC puncture tests, nearly circular puncture holes can be observed along with severe through-the-thickness material losses. For Panel 4, which was subjected to the LI voltage test, much less material loss at the surface can be observed and that the removed material created a highly elliptical shape (about 1.59 mm in longer length) rather than near circular shape by the HVAC puncture test. Moreover, the LI voltage test inflicted much severe delamination within and at the near surface layers of Panel 4. Such damage shapes are similar to the findings of Garolera et al.<sup>30</sup> who studied actual cases of direct lightning attachment damage to wind turbine blades from wind farm reports where they all appear to be long and narrow in shape along with delamination near the

lightning attachment point. S-scan images for Panels 2, 3, and 4 shown in Figure 4 further confirmed these visual inspections, the color legend represents the signal amplitude across the detection probe for which strong signal amplitude indicates solidity at the front wall and back surface and lower signal amplitude indicates interlaminar delamination. The Image Processing and Analysis in Java (ImageJ) software was used to quantify the near surface material loss and interlaminar delamination areas of the panels. The material loss area on the GFRP surface integrates areas of the total pixels displaying the complete fiber and matrix material removal. The interlaminar delamination area integrates the areas of the total pixels displaying the black charred areas (i.e. resin fully decomposed, and thus, delamination occurs). The near surface material loss areas for Panels 2, 3, and 4 are 1.625, 1.375, and 0.458 mm<sup>2</sup>, respectively, as shown in Figure 5. The interlaminar delamination areas are 24.121, 11.561, and 133.062 mm<sup>2</sup>, for Panels 2, 3, and 4, respectively, as shown in Figure 6. Given the different bonding materials (washers vs. electrodes) for Panels 2 and 3, it appears that the dimension of the bonding material highly affects the surface material loss and the delamination area. With the smaller dimension of the washer, the electric current flows into the material could be constricted and therefore the current density becomes higher which results in more extensive thermal damage in the GFRP composite.

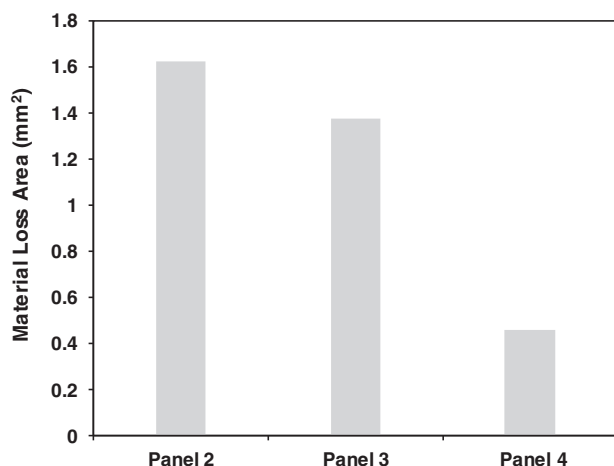
**Figure 5.** Comparison of near surface material loss area for Panels 2, 3, and 4.

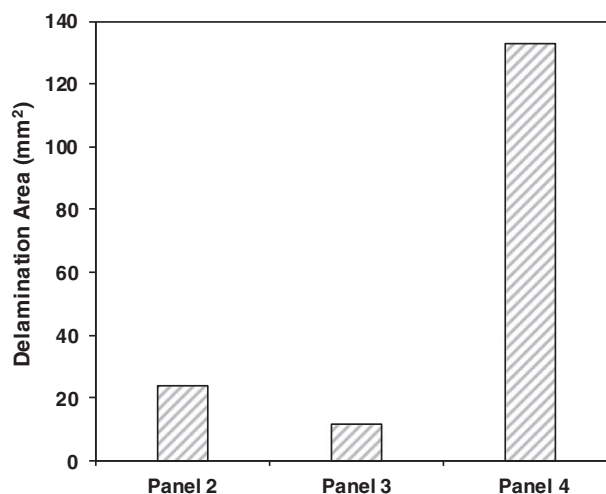
**Figure 6.** Comparison of interlaminar delamination area for Panels 2, 3, and 4.

vaporization and matrix recession, the high voltage puncture also causes a large area of delamination as evidenced by our experimental tests (see Figure 5). The delamination of the composite could be caused by the electromagnetic force and the acoustic shock wave, which was not predicted from our model and will be a topic of our future work.

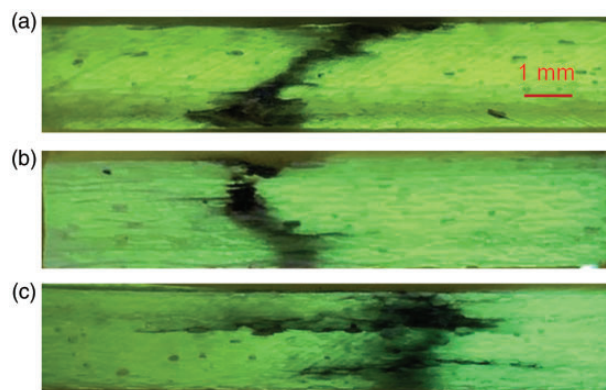
Figure 7 shows the cross-sections of the GFRP composite panels after the HVAC and LI high voltage experimental tests. As we can see, Panels 2 and 3, which were subjected to HVAC tests, were completely punctured from the top to the bottom surface of the material. They exhibit similar breakdown paths, except that the path in Panel 2 is less straight than that in

**Figure 7.** Cross-sections of the GFRP composite panels after high voltage experimental tests: (a) Panel 2 after HVAC test; (b) Panel 3 after HVAC test; and (c) Panel 4 after LI test. HVAC: high voltage alternating current.

Panel 3. This difference could be due to the difference in the puncture voltage and the GFRP composite material deficiencies. The puncture diameter for Panels 2 and 3 is in the range of 0.4–0.8 mm. In contrast, Panel 4, which was subjected to the LI test, exhibited distinct damage modes than Panels 2 and 3, where more significant delamination and less material loss can be observed.

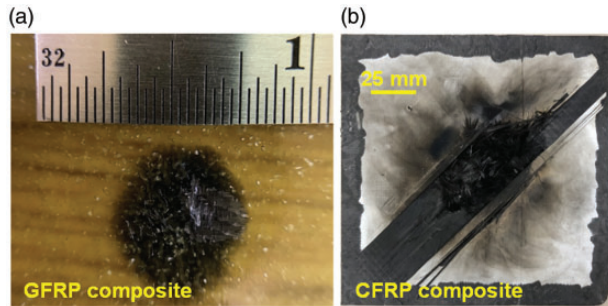
It is worth noting that the lightning strike high voltage damage in GFRP composite is quite different from the typical lightning strike damage in CFRP composite, as shown in Figure 8. The difference is due to the different material properties (explained in detail in the SEM imaging section below). As we can see, the CFRP composite shows more extensive damage on the material surface, including delamination, charring, fiber breakage and fiber pullout, and matrix cracking.

**Figure 8.** Lightning strike damage in (a) GFRP composite (Panel 4 under LI test condition) and (b) CFRP composite (under impulse current with a peak of 100 kV). GFRP: glass fiber-reinforced polymer.

Typically, only top few composite layers will be affected by the lightning strike for CFRP. Direct puncture damage across the entire panel thickness and deep interlaminar delamination, as those observed in our GFRP panels, are not common for CFRP composite and have not been reported.

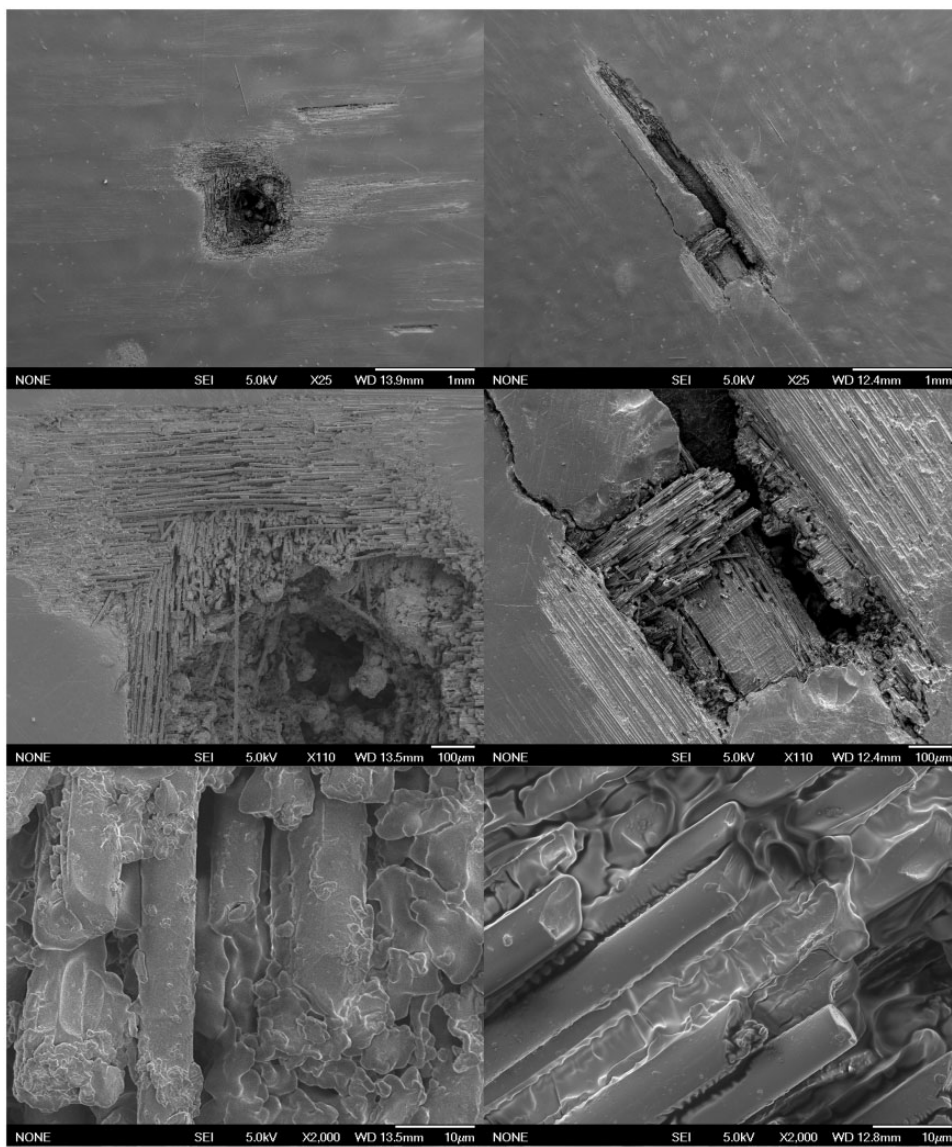
Figure 9 shows the SEM images for Panels 3 and 4 at varying magnification levels. For Panel 3 which was subjected to the HVAC puncture test, the damage appeared to be circular in shape along with extensive amount of matrix vaporization and fiber breakages, whereas for Panel 4 which was subjected to the LI voltage waveform A strike, the damage appeared to be long and narrow which could be explained by the much higher energy level and shorter duration of pulsed current comparing with the HVAC puncture test. Similar damage modes, such as matrix vaporization and fiber breakages, can also be found on Panel 4. In addition to that, matrix cracking was found at the GFRP composite surface and delamination was found at the near surface layers. The circular shape damage for Panel 3 is related to the circular geometry of the electric arc plasma formed when the GFRP is punctured under the HVAC puncture test. When compared to the HVAC test, the LI voltage test requires a much higher voltage to puncture the GFRP ( $\sim 182$  kV vs. 80 kV). With the rapid rising of the electric voltage ( $1000$  kV/ $\mu$ s, see Figure 1), it was initially difficult to puncture the GFRP composite. Instead, it searches for the least resistance path on the material surface to conduct the electric current. Since the electrical conductivity in the fiber direction is higher than that in the through-the-thickness direction (due to interlaminar resin-rich regions), the electric current initially attempts to flow in the fiber direction ( $45^\circ$ , i.e. the orientation of the first ply) on the material surface

before it finally punctured. Therefore, the surface damage on Panel 4 appears to be long and narrow. Such damage has also been reported in many experimental studies for CFRP composites subjected to simulated lightning strike tests.<sup>9,11,14</sup>

Figure 9. SEM images for (a) Panel 3 and (b) Panel 4 at varying magnification levels.

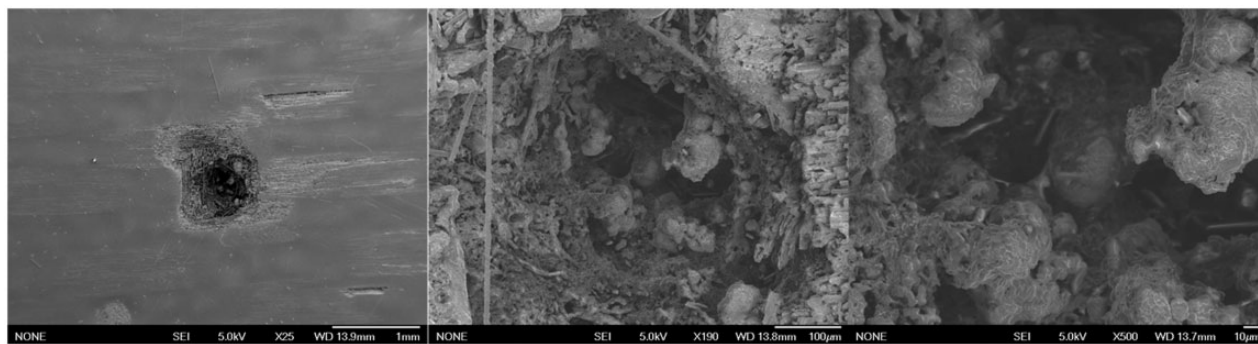
Figure 10 shows the SEM images for Panel 3 at the central regions where massive matrix charring and material loss (0.4 mm in radius, 0.8 mm through the thickness) due to fiber vaporization can be observed, and the char residue was deposited at the ends of the broken fibers. The results imply that the damage of the GFRP composite material when subjected to the HVAC puncture is more dictated by the thermal effect, whereas the damage when subjected to the LI voltage waveform A strike is more dictated by the impact effect, potentially due to the shock wave and electromagnetic force produced by the lightning strike. Here, the thermal effect caused by the HVAC puncture for GFRP is different from the thermal effect caused by lightning strike for CFRP. Although both thermal effects are mainly from the resistive heating, the damage mechanisms are different due to the difference between their thermal conductivity ( $0.8$  W/m $\cdot$ °C for GFRP and  $34$  W/m $\cdot$ °C for CFRP in the longitudinal direction at room temperature<sup>19,44</sup>) and electrical conductivity ( $2.17 \times 10^{-16}$  S/m for GFRP and  $3.38 \times 10^4$  S/m for CFRP in the longitudinal direction at room temperature<sup>19,44</sup>). The GFRP is electrically insulating in normal conditions. But when an extremely high voltage (80 kV in HVAC test and 187 kV in LI test) is applied, the dielectric breakdown phenomenon occurs and a conductive path is created to pass through high current density, as shown in Figure 7.

Figure 10. SEM images for Panel 3 at central region at different magnification levels.
