# Analysis of damage modes of glass fiber composites subjected to simulated lightning strike impulse voltage puncture and direct high voltage AC puncture

Journal of Composite Materials  
2020, Vol. 54(26) 4067–4080  
© The Author(s) 2020  
Article reuse guidelines:  
sagepub.com/journals-permissions  
DOI: 10.1177/0021998320927736  
journals.sagepub.com/home/jcm

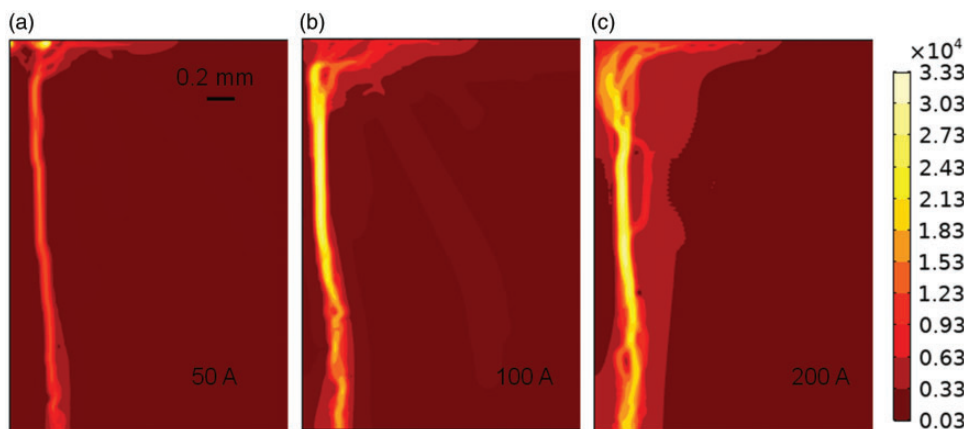
**Figure 12.** The temperature (unit in K) of the electric arc plasma formed in the GFRP composite due to the high voltage puncture at  $1 \mu\text{s}$  and at current levels of (a) 50, (b) 100, and (c) 200 A.

and does not propagate through the thickness. This implies that the puncture through the thickness becomes difficult as the current (or voltage) level decreases. A 3D representation of the electric arc plasma generated in the GFRP composite panel is obtained through revolution of the 2D solution about the  $z$  axis and shown in Figure 13. It can be noticed that the plasma in the GFRP composite forms an approximate hollow cylindrical shape. The radii of the hollow cylindrical channels are 0.35, 0.28, and 0.22 mm. Here, the radius is taken as the distance between the center of the plasma channel (where maximum temperature occurs) and the  $z$  axis. It appears that when the current level increases, the cylindrical plasma gradually converges to the  $z$  axis. If the discharge duration is sufficiently long, the hollow cylindrical plasma channel converges and becomes a solid plasma channel through

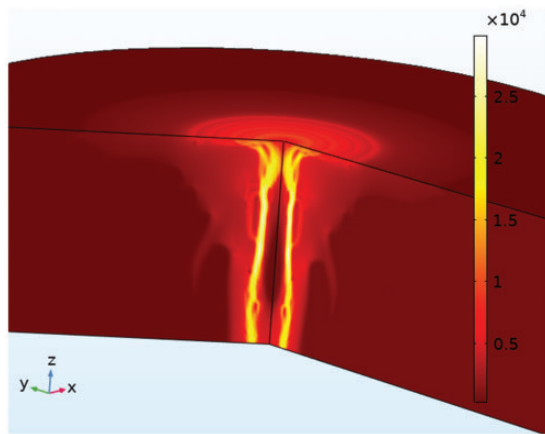
the thickness of the composite (see results in the next section). Due to the strong ionization, the material in the plasma channel is presumed to be completely vaporized, leaving a puncture in the composite panel. Moreover, the extreme high temperature from the plasma also leads to matrix decomposition in the regions adjacent to the plasma channel, which results in the deposition of the carbon residue at the ends of the broken fibers. With a hollow cylindrical plasma channel obtained from the current simulations, a ring-shaped puncture is expected to be observed (see Figure 13). However, our experimental examinations from the high voltage tests found either a circular shape or an elliptical shaped material loss (see Figure 9). This inconsistency implies that the discharge duration could be larger than  $1 \mu\text{s}$  (see results in the next section) and/or the actual current could be much higher than 200 A. At the same time, in addition to the material

**Figure 13.** A 3D representation of the electric arc generated in the GFRP composite panel at 200 A and  $1 \mu\text{s}$  (temperature unit in K).

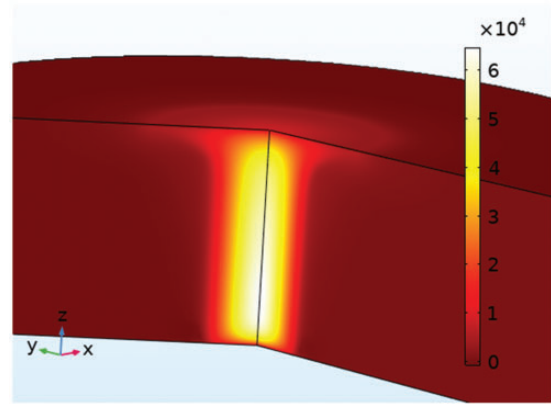
**Figure 15.** A 3D representation of the electric arc generated in the GFRP composite panel at 200 A and  $100 \mu\text{s}$  (temperature unit in K).

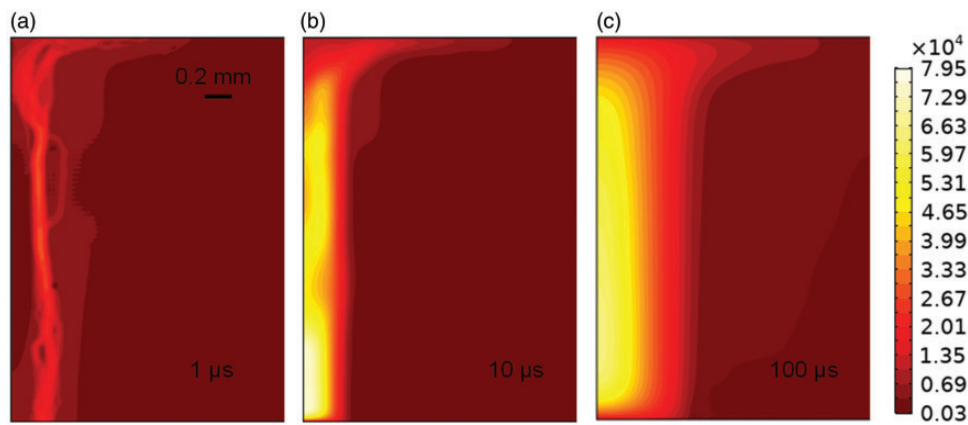
**Figure 14.** The temperature (unit in K) of the electric arc plasma formed in the GFRP composite due to the high voltage puncture at 200 A and with durations of (a) 1, (b) 10, and (c)  $100 \mu\text{s}$ .

Additional simulations were carried out to investigate the effect of the current duration on the electric arc plasma formation and the composite puncture damage. Figure 14 shows the simulation results for the plasma temperature in the GFRP composite panel at 200 A with durations of 1, 10, and 100  $\mu$ s. It can be seen that the electric arc plasma channel has grown from a hollow cylindrical channel to a solid cylindrical channel when the duration was increased to 10 and 100  $\mu$ s. Figure 15 shows the 3D representation of the electric arc plasma at 200 A and at 100  $\mu$ s. The radii of the solid cylindrical plasma, and hence the puncture sizes, are 0.55 and 0.85 mm at 10 and 100  $\mu$ s, respectively. The predicted puncture sizes agree quite well with our experimental test data for panels tested under the HVAC condition (see Figure 7). Here, the radius is taken as the average distance between the 1700 K isothermal line (i.e. melting temperature of glass fiber) to the  $z$  axis. The simulation results imply that the electric arc plasma starts with a hollow cylindrical shape during the beginning of the discharge and gradually converges to a solid cylindrical shape. As the discharge duration increases, the radius of the solid cylindrical plasma channel and hence the size of the puncture grows. The expansion of the electric arc plasma leads to a larger material loss area (i.e. puncture size), which agrees with our experimental observations where the material loss areas subjected to the long-duration HVAC test are generally larger than that subjected to the short-duration LI voltage test.
